# Wildlife Usage of a Constructed Wildlife Underpass

*Submitted by: P. Chase Bernier, Wetland/Wildlife Scientist, BSC Group, Inc., Alexandra (Ale) Echandi, Wetland/Wildlife Scientist, BSC Group, Inc. and Jessica Kenny, Manager of Ecological Compliance, Construction, Massachusetts Department of Transportation—Highway Division*

**As part of the Route 2 Crosby's Corner Safety Improvement Project in Lincoln and Concord, Massachusetts, the Massachusetts Department of Transportation (MassDOT) constructed a wildlife tunnel adjacent to Mill Brook which provides habitat connectivity and safe passage for wildlife. The tunnel is 8-ft x 6-ft and spans 130 feet, bisecting the Route 2 corridor. Construction of the tunnel was completed in the fall of 2015. MassDOT developed a comprehensive wildlife monitoring protocol to document the efficacy of the tunnel including the use of track beds, camera traps, a road mortality survey, and snow tracking. The lack of sufficient snowfall during the survey period prevented snow tracking from occurring to date.**

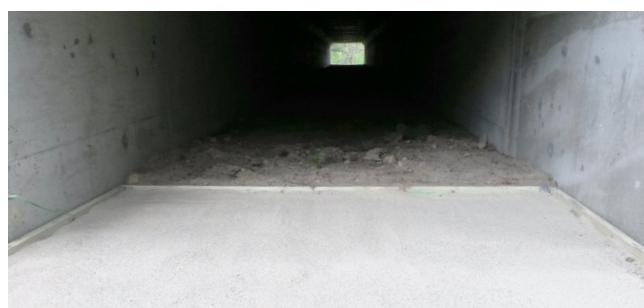
A view looking south through the tunnel from the north track bed.

The study area of the track beds and camera traps was limited to the area of the tunnel and the immediate area adjacent to the entrances. The tunnel substrate consisted of exposed loose soil with a high gravel and cobble content approximately 1 foot in depth. The walls and ceiling of the tunnel were comprised of concrete. Immediately adjacent to the north and south entrances of the tunnel consisted of upland grassy slopes.

The northern track bed was set flush with the entrance of the tunnel and extended inward 6 feet. The middle bed was set 75 feet in the center of the tunnel. The southern bed was installed with half of the bed in the tunnel and half extending beyond the entrance to capture crossing attempts wherein individuals may approach the tunnel, but not enter.

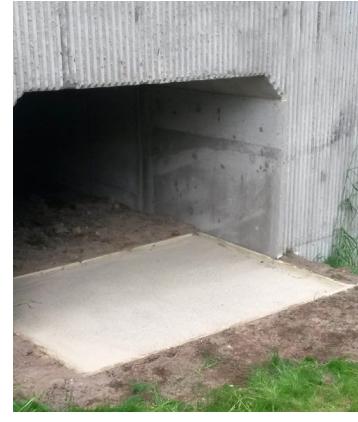
View of the south tunnel entrance and track bed.

The track beds were effective in accurately recording species' movements; however, it was often difficult to properly identify the individual tracks to species level due to being weathered and tracked over. As the season progressed, the north and south beds experienced aggressive weed growth resulting in false triggers of the camera traps and reduced the effectiveness of the beds.

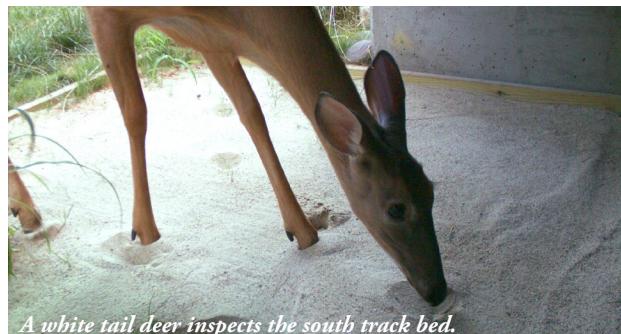
A white tail deer inspects the south track bed.

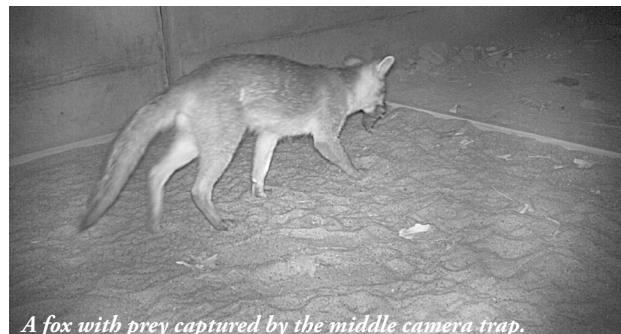
A fox with prey captured by the middle camera trap.

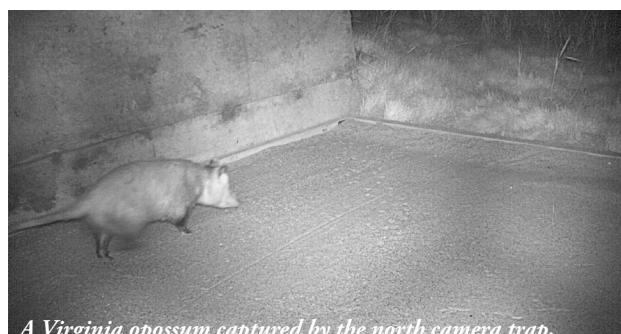
A Virginia opossum captured by the north camera trap.

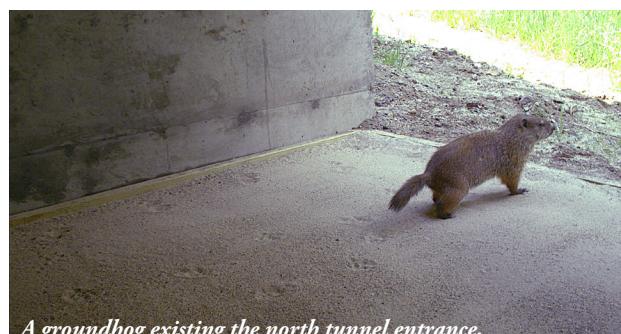
A groundhog exiting the north tunnel entrance.
